Case Study

AutoTechnica is a Hertz fleet service company. The company provides vertical services in five (5) privately held premises located in Athens, Thessaloniki & Crete.

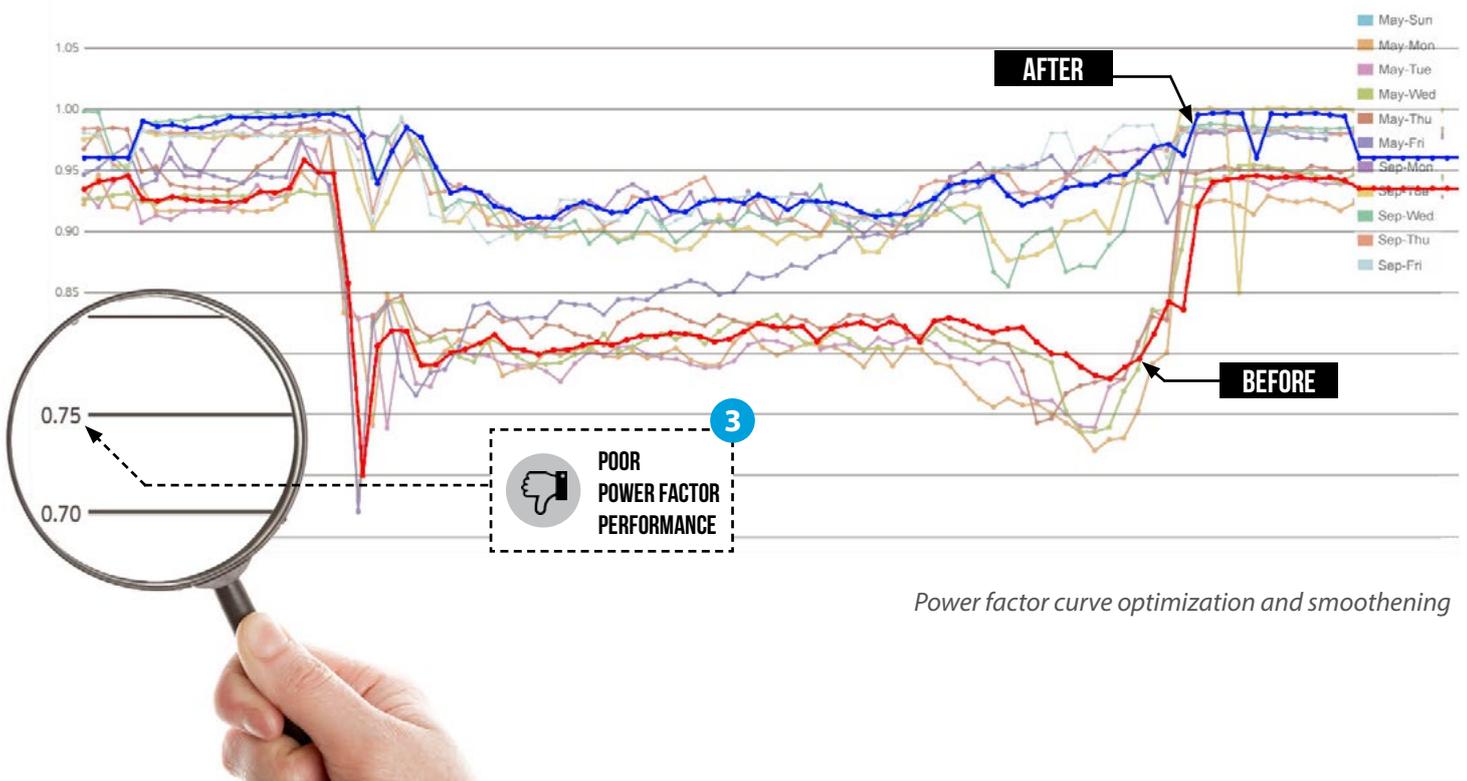
Power factor curve optimization and smoothing

- a. The installed florescent type lighting caused poor power factor performance.³
- b. The light switching behavior of the facility users revealed increased discomfort.
- c. The service station equipment's start & stop kept the energy pattern close to power line capacity.²

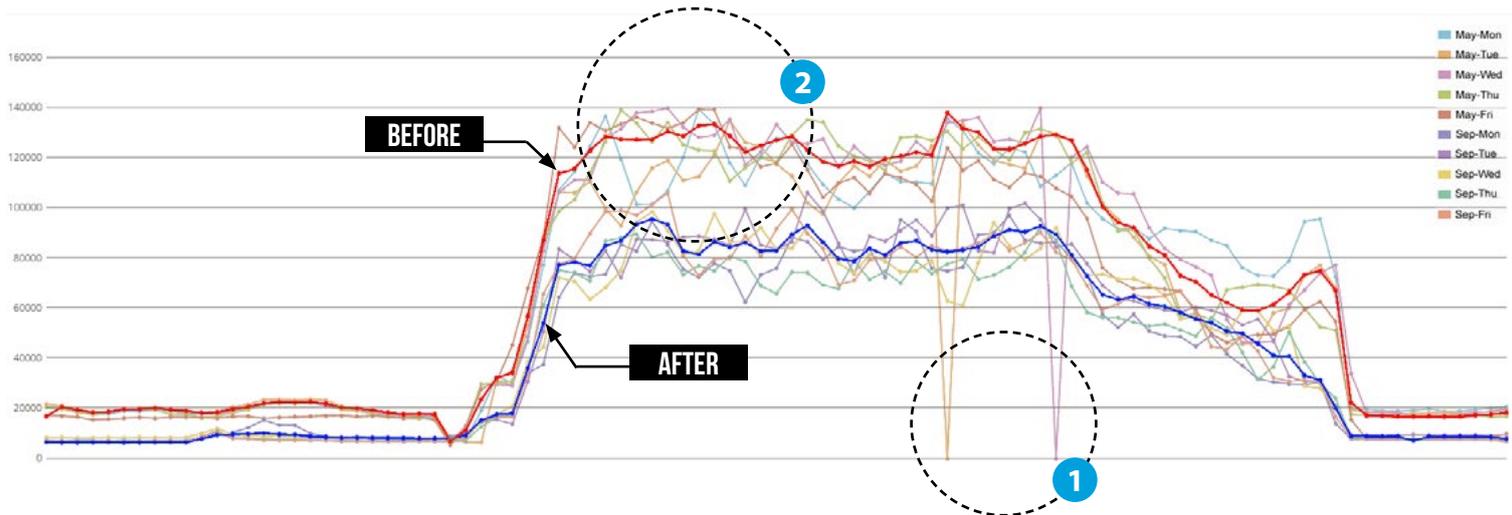
Equipment scheduling through substantial power arbitrage to smoothen & optimize the load demand curve

- a. Service station equipment control (i.e. regulated parallel operation) through substantial power arbitrage to smoothen and optimize the load demand curve and
- b. LED lighting retrofit to significantly lower the base load level due to their high efficiency.
